Pericardial Effusion

Department of Radiology FMC Umuahia, Abia State, Nigeria

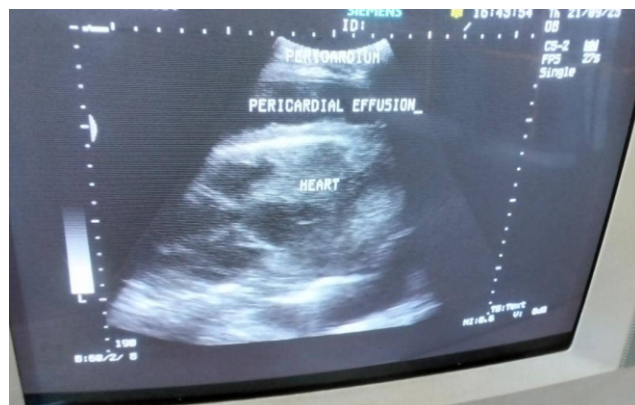
Fig 2. Ultrasounds scan of Pericardial Effusion

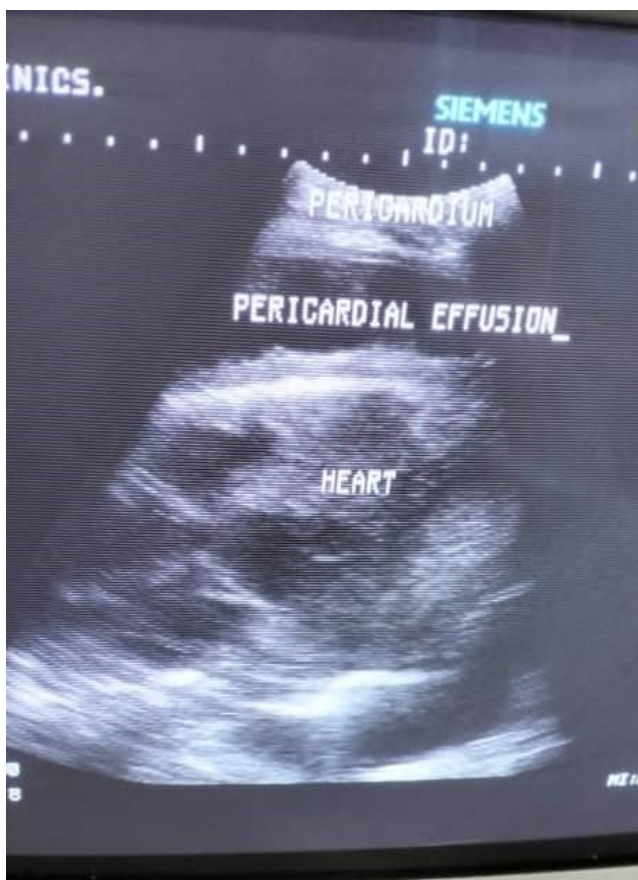
Fig 1. Transthoracic echocardiography of Pericardial Effusion

space between the heart and the pericardium which was concentric, the depth of the echo free space correlated with the fluid accumulation, with fluid thickness of 1.5cm approximately 250ml of serous pericardial fluid. Echocardiography also revealed Compression of the right atrium and ventricle with taponade effect on heart resulting in the diastolic collapse of the right atrium and ventricle. Color Doppler interrogation of the heart revealed abnormal blood flow patterns. Emergency ultrasound guided pericardiocentesis provided immediate symptomatic relief for the patient. Fluid analysis indicated an exudative effusion, prompting further investigations to determine the underlying etiology. This case underscores the critical role of radiographic imaging, including chest X-rays and echocardiography, in diagnosing and characterizing pericardial effusion, enabling timely intervention and optimal patient care with coordination among emergency medicine, cardiology, and diagnostic imaging specialists.

Echocardiography, a valuable diagnostic tool, provided a more detailed assessment of the pericardial effusion. Transthoracic echocardiography (TTE) revealed a moderate effusion, with an estimated fluid thickness of 1.5 cm. importantly; it indicated tamponade physiology, demonstrated by diastolic collapse of the right atrium and ventricle, underscoring the urgency of intervention.³
